# Delamination

Advisory engineer  
John Plimmer discusses  
the phenomenon of  
delamination

## of concrete floor surfaces

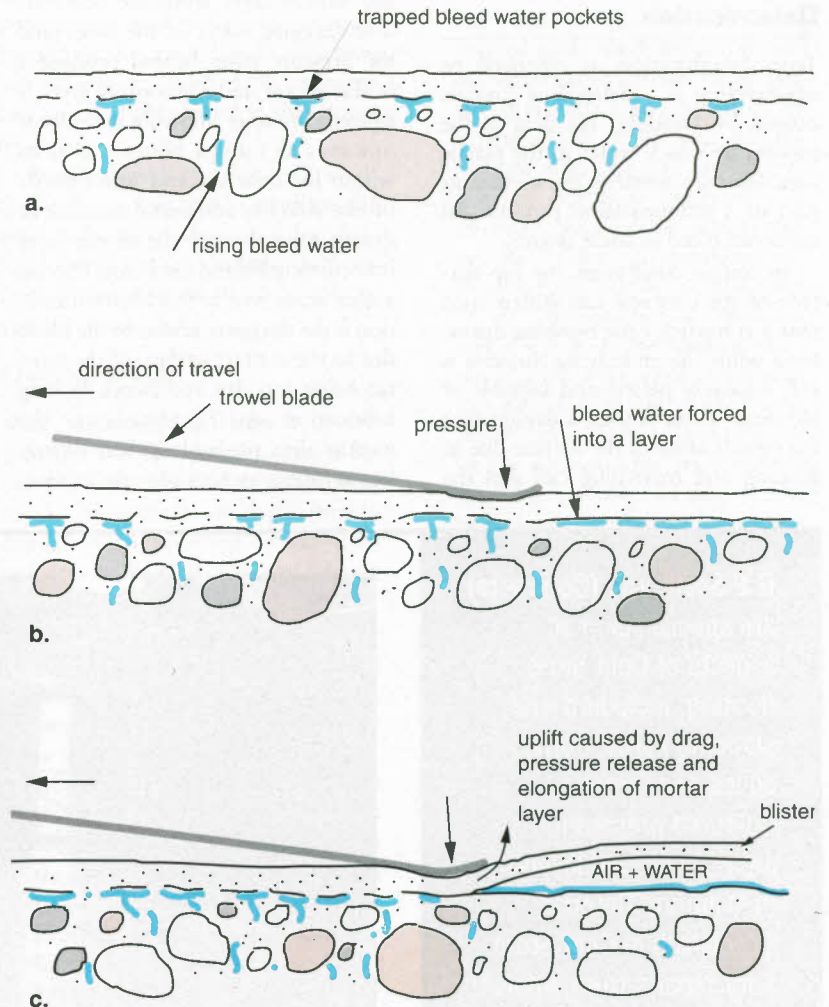
Figure 1: Delamination mechanisms

top and trap the bleed water still trying to rise to the surface. A plane of weakness is then formed: see Figure 1a. If further trowelling takes place at a critical time, this plane of weakness can be extended as shown in Figure 1b. There is no way the floor finisher can realise this is happening unless blistering occurs, as illustrated in Figure 1c. Here a feature which looks exactly like a blister forms under the action of trowel blades. The pressure exerted by the blade tends to spread the bleed water, completely separating the mortar layer from the concrete. The dragging effect of the blade and the pressure relief behind produce a lifting action and the mortar layer is squeezed thinner allowing it to dome upwards to form a blister. Air from within the concrete and water partly fill the void but additional air must be drawn down through the mortar layer immediately behind the blade. Playing a significant role in this blister formation is the dragging action of the blade due to the contact surface of the mortar being too dry and hence lacking lubrication. At the same stage the mortar skin probably splits, slightly letting out water to provide lubrication,

With such a defect, the surface characteristics of the underside of the delaminated layer varies depending upon the severity of the problem as illustrated in Figure 1. The surface will be granular and, in marginal cases as in Figure 1a, the particles will be well covered with cement paste. There will be some clean surfaces of aggregate due to the presence of water and there may be evidence of lime bloom and silty material on the exposed concrete surface. In severe cases, the surface will still have a granular texture but washout will be more evident, with more clean washed surfaces and clean silt and fine sand present.
